Installation instructions

For set # 3.3190

1999-04 CHEVY / GMC

K1500 SILVERADO / SIERRA 4WD

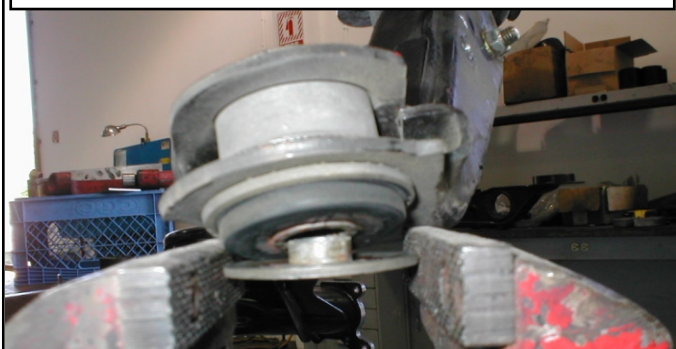
DO NOT REMOVE OUTER METAL SHELL FROM UPPER CONTROL ARM.

To remove cap washers on upper control arm, clamp cap washer in vice and wiggle arm back and forth. Inner sleeve is not bonded, use spray lube to help press it out.

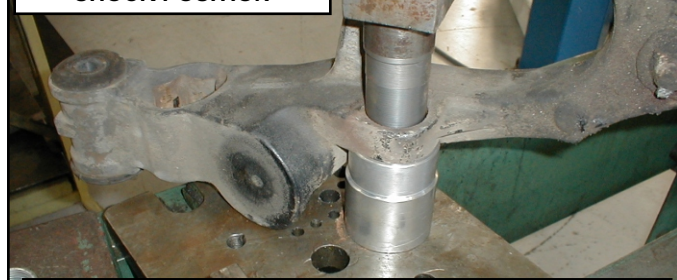
LOWER CONTROL ARM SHOCK POSITION

The outer metal shell must be pressed out before installing the new shock bushings. I.D. of control arm is $\varnothing 1.610$ ". Press out shell with something smaller than $\varnothing 1.610$ ".

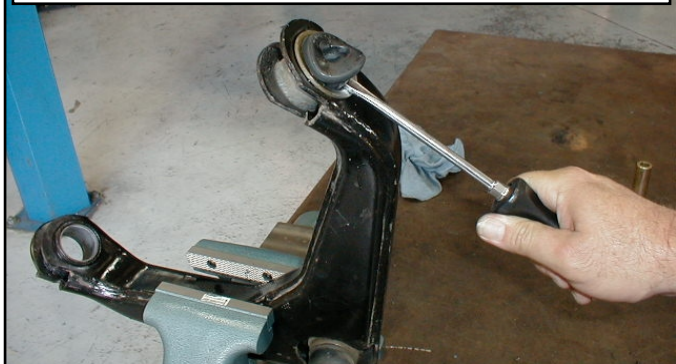
After inner sleeve has been removed, pry out old bushing. Make sure inside surfaces are free of all old bushing material and sharp edges. Coat urethane bushing, sleeve and shell I.D. with supplied grease. (all surfaces of bushings that contact metal). Inner sleeve and cap washer must be reused.

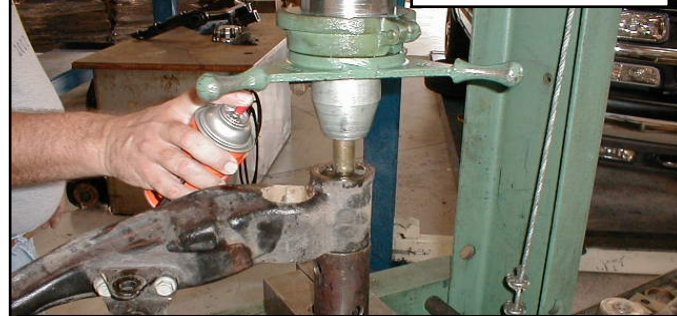
Lower control arm

There is no outer metal shell to press out. The rubber bushings are bonded to the inner sleeve, but not the control arm. Press the bushing/sleeve out as a unit. Use spray lube to help remove the old rubber bushings from the lower control arms.
